Manhole Inspection Summary

Manhole # S11GG1007MH

Location Address: **4340 W COLD SPRING LANE** Cross Street: **REISTERSTOWN RD**

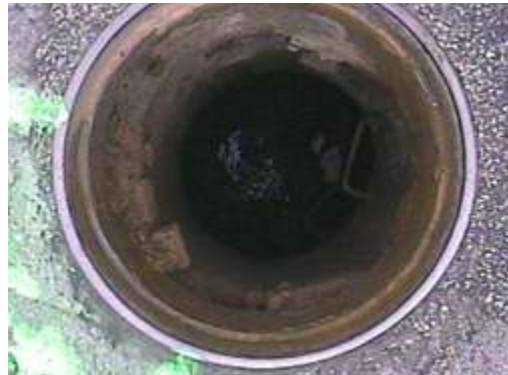
Top View

Frame Offset: **2** (in.) Condition: ☒ Sound ☐ Cracked ☐ Leaks

FRAME OFFSET

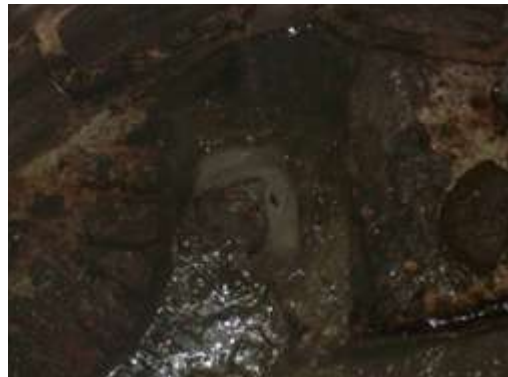
Defect 2

DEBRIS ON BENCH AND IN CHANNEL

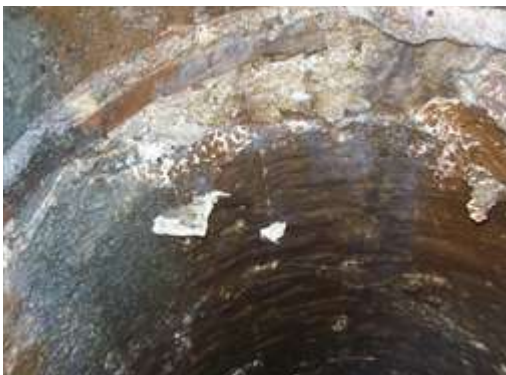
Defect 1

Chimney / Frame Adjustment ☒ Exists Material: **Brick** ☐ Parged Height: **5** (in.)

Condition: ☐ Sound ☐ Cracked ☐ Root Intrusion ☒ **Loose Brick** ☒ **Deteriorated**

CHIMNEY LOOSE BRICKS AND
DETERIORATION

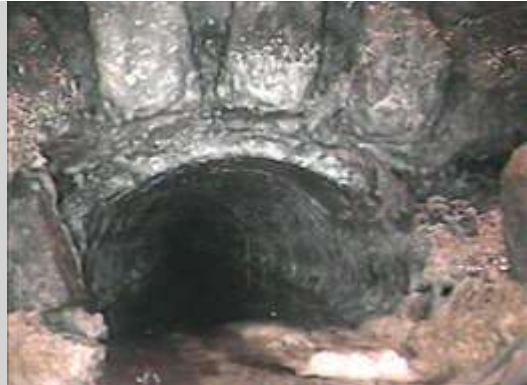
12 O'Clock Outflow

Pipe Height: (in.) Direct
Pipe Material: **Clay** ☐ Pipe Lined
Invert Depth: **9.70** (ft.) Flow Characteristics: **Slow**
Deposits: ☐ None ☐ Mud ☒ Sludge ☒ Debris ☐ Grease
Silt Depth: **2** (in.) Deposits Extent: **Light**
Infiltration: **None** Pipe Seal Cond: **Sound**

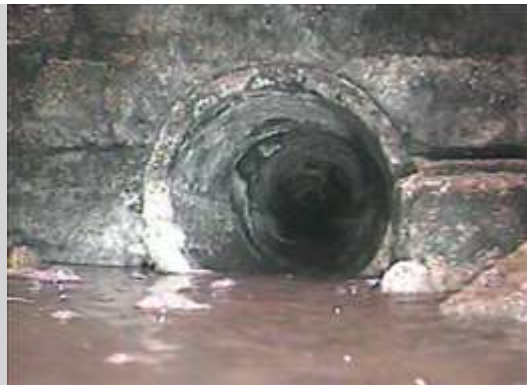
6 O'Clock Inflow

Pipe Height: (in.) Direct
Pipe Material: **Clay** ☐ Pipe Lined
Invert Depth: **9.40** (ft.) Flow Characteristics: **Slow**
Deposits: ☐ None ☐ Mud ☐ Sludge ☐ Debris ☒ Grease
Silt Depth: **1** (in.) Deposits Extent: **Light**
Infiltration: **None** Pipe Seal Cond: **Sound**
